## Fort Leonard Wood Culvert and Flagpole

Historic American Engineering Record

April 2011

Final Report

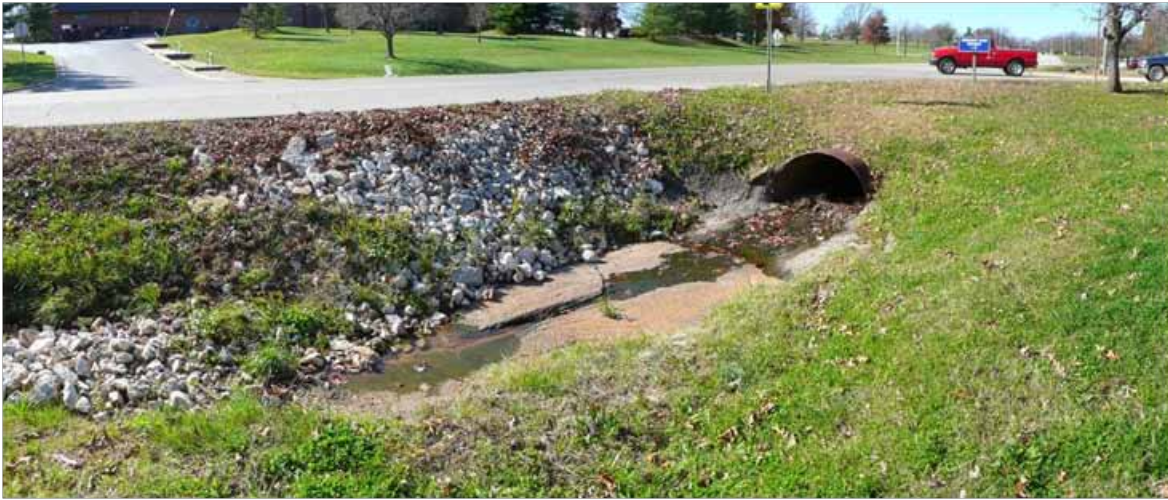
On the east side of Illinois Avenue, the culvert is simply a semi-circular corrugated steel tube with a flat bottom. The tube is approximately 36-in. tall and the flat base is approximately 64-in. across. The tube projects approximately 24 in. from the surface of the hillside. The culvert empties into an area of aged and worn concrete, then an area of different sized cobblestones and small boulders, and eventually into an area of dirt and grass. The south embankment consists of the same loose stone and the north embankment is entirely grass.

Figure 5. Overall view of east side of culvert.

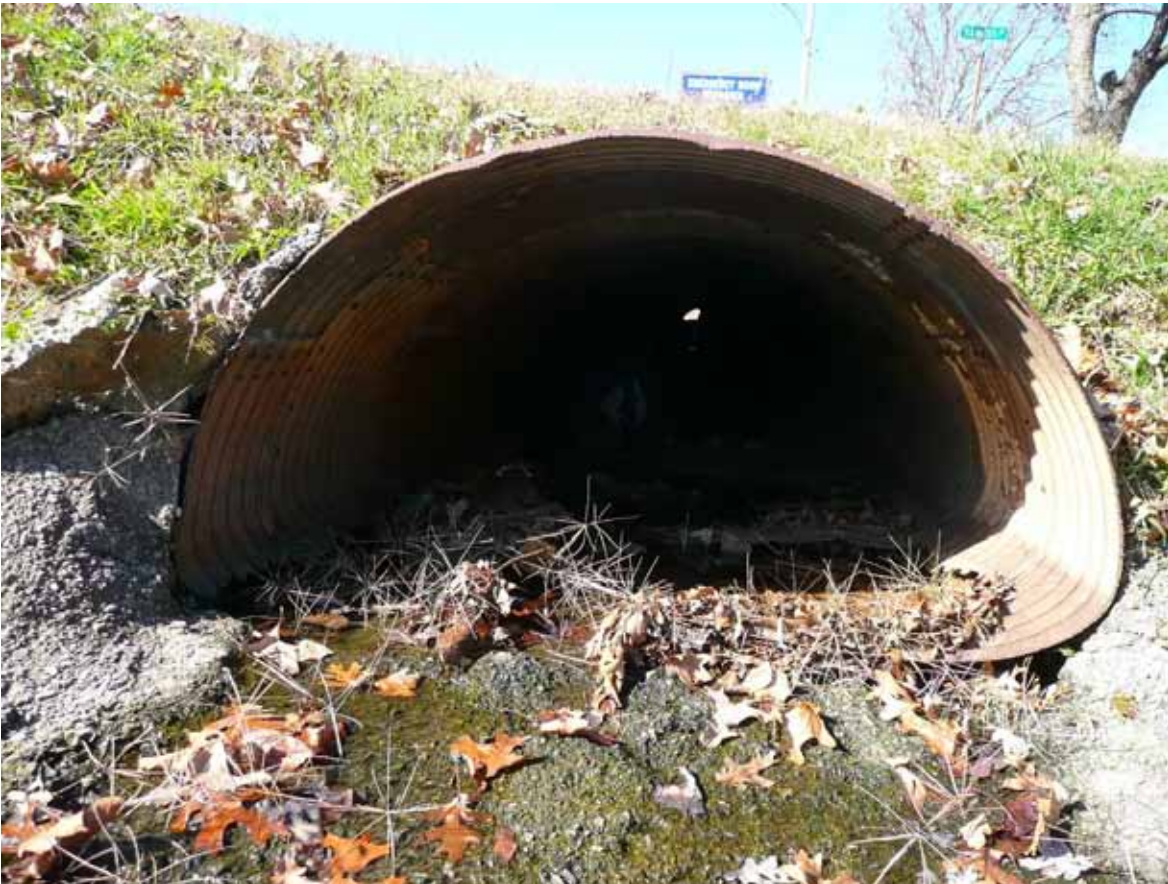
Figure 6. East elevation of culvert.

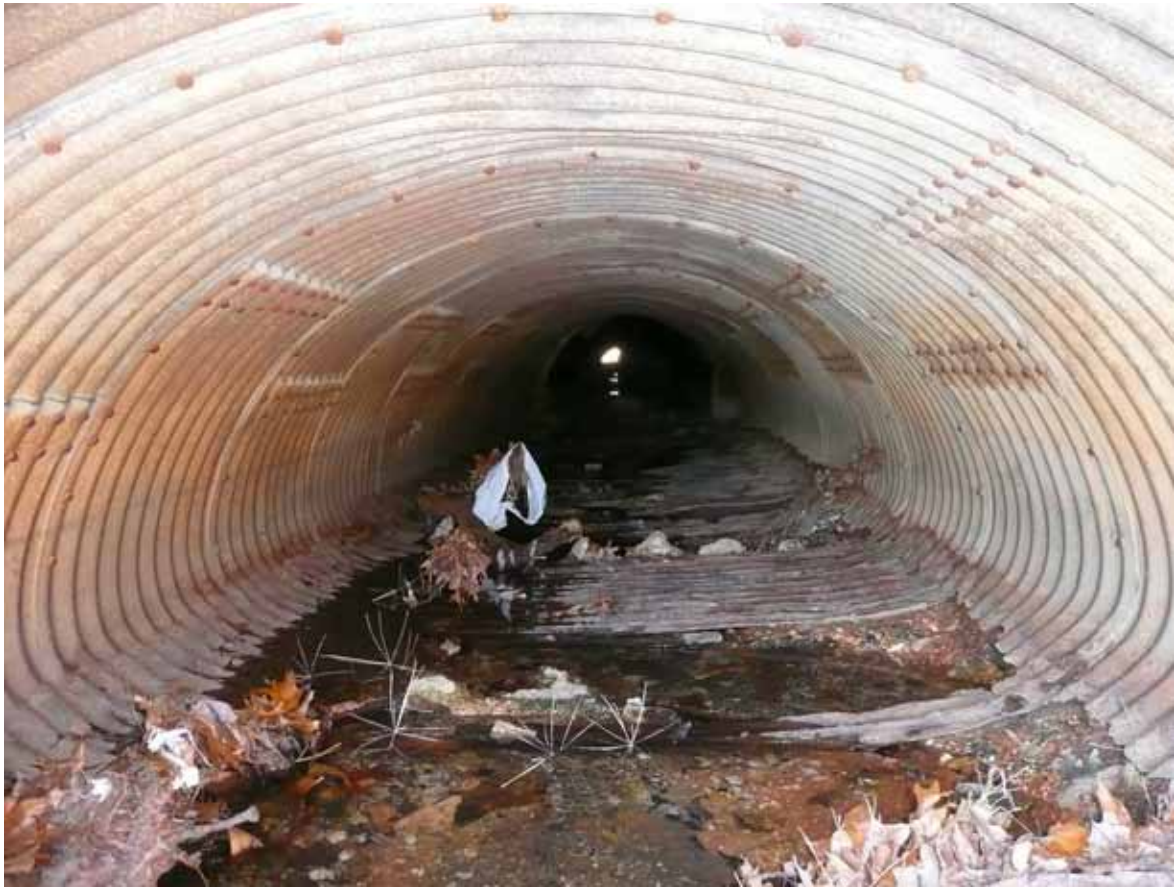
The steel tube is rusted, but appears to be in good condition. The stone wall on the west side of Illinois Avenue is in good condition with the exception of some cracked and missing mortar. The walls of the ditch are in poor condition with almost no mortar and missing stones.

Figure 7. Inside of culvert, east end.

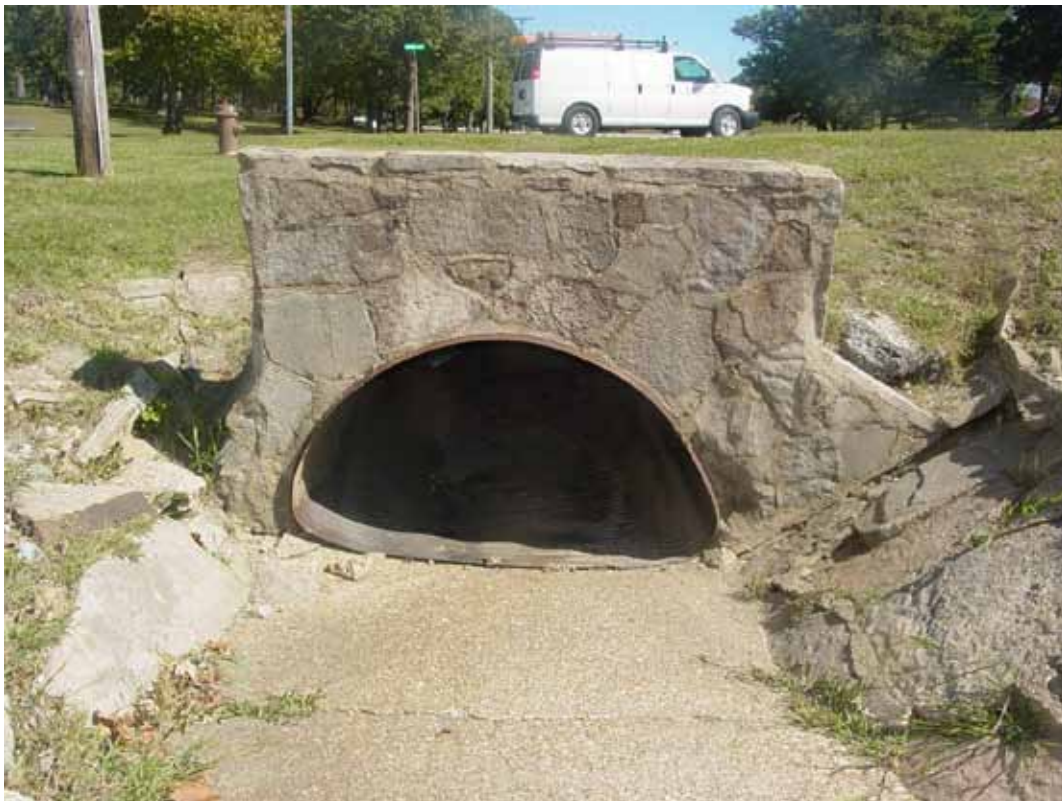
The culvert on the west side of Illinois Avenue is much different than on the east side. The bottom of the ditch has a longer stretch of concrete that is approximately 6-ft wide and is in good condition. The corrugated steel tube is the same size and shape as the east side, but is embedded into a stone wall that runs north-south. The wall rises approximately 27 in. above the top of the corrugated steel tube. The stone wall is approximately 88 in. across with the steel tube slightly off center toward the north and expands at the base in a bell shape. The wall is 12 in. thick on the north end and expands to 17-in. thick on the south end.

Figure 13. West elevation of culvert.

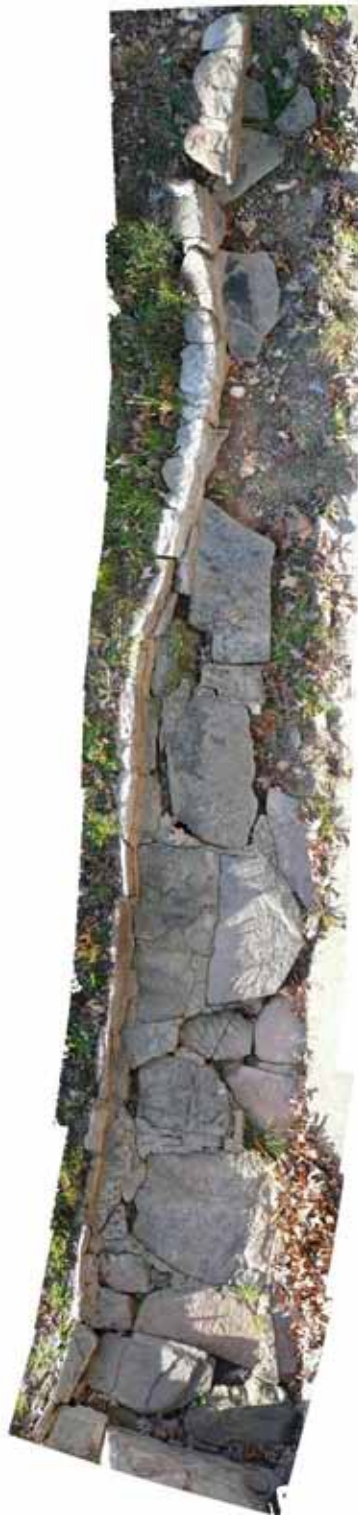
Figure 18. Overall elevation of south embankment, west side of culvert.

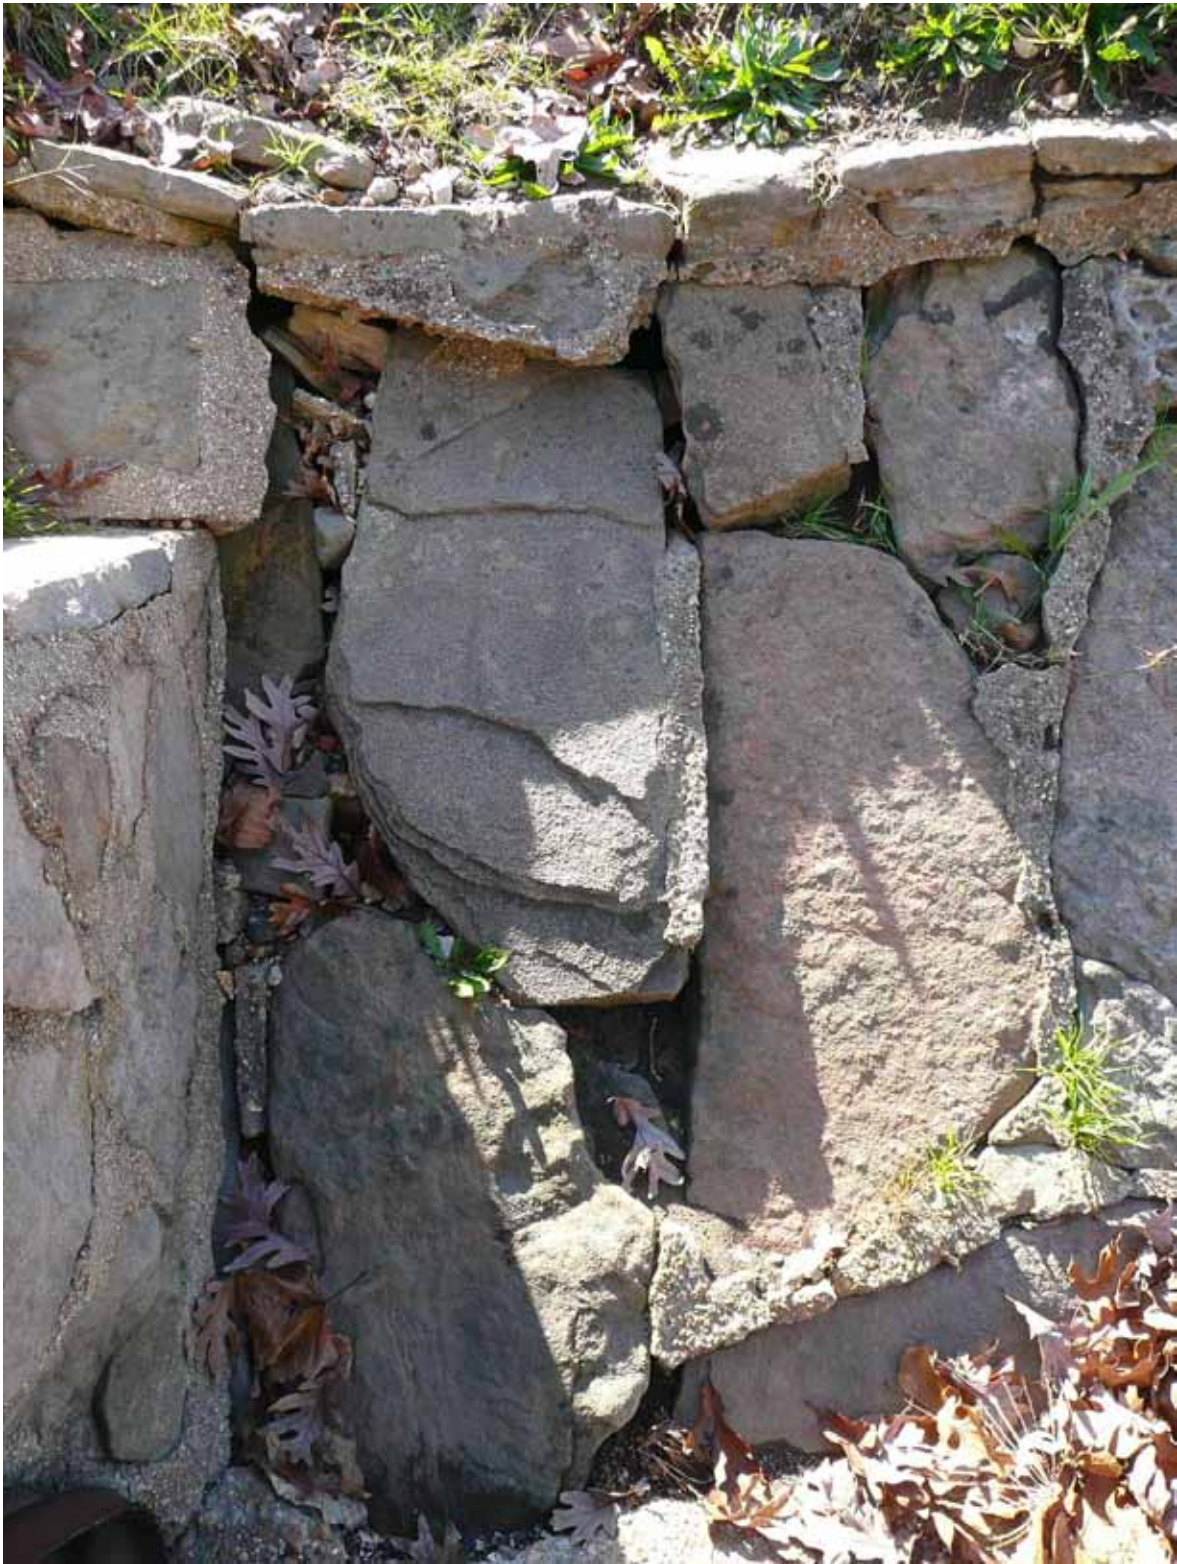
Figure 19. Detail of south embankment, west end of culvert.

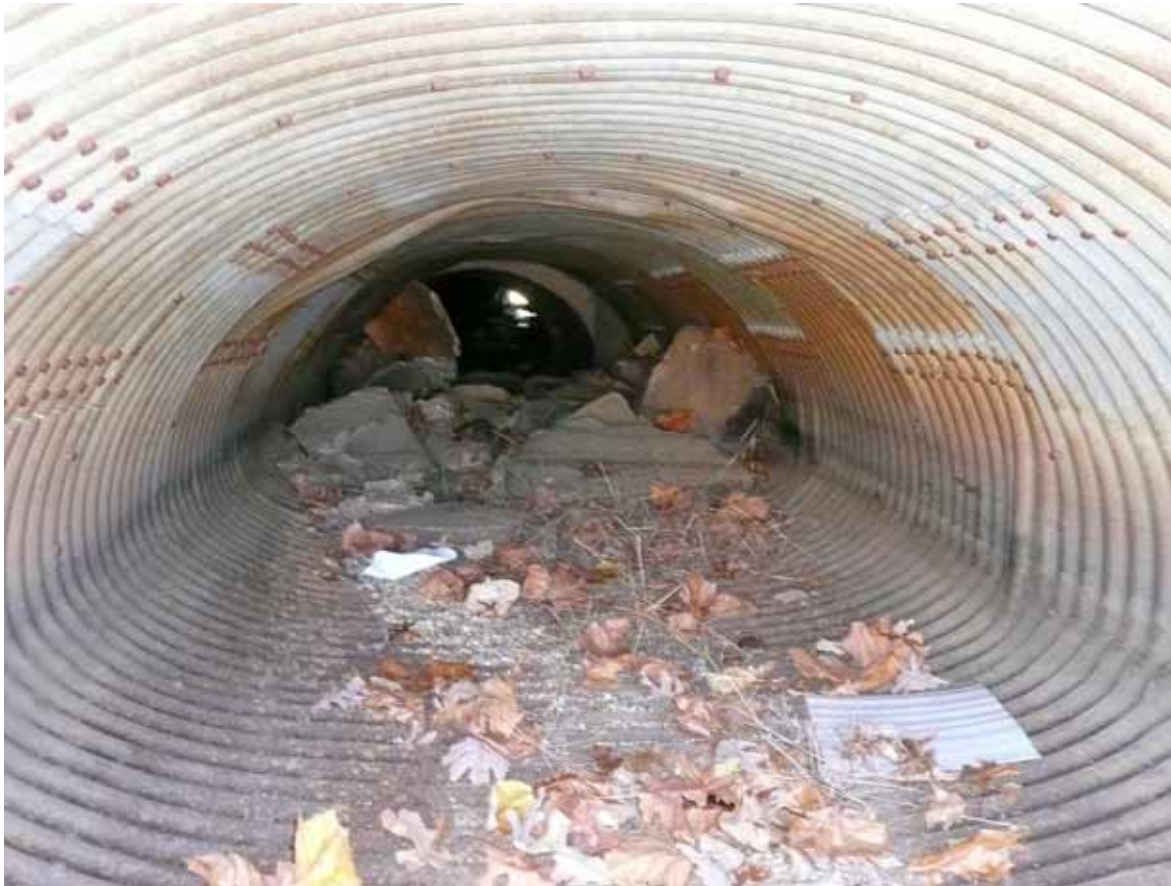
Figure 20. Inside west end of culvert.

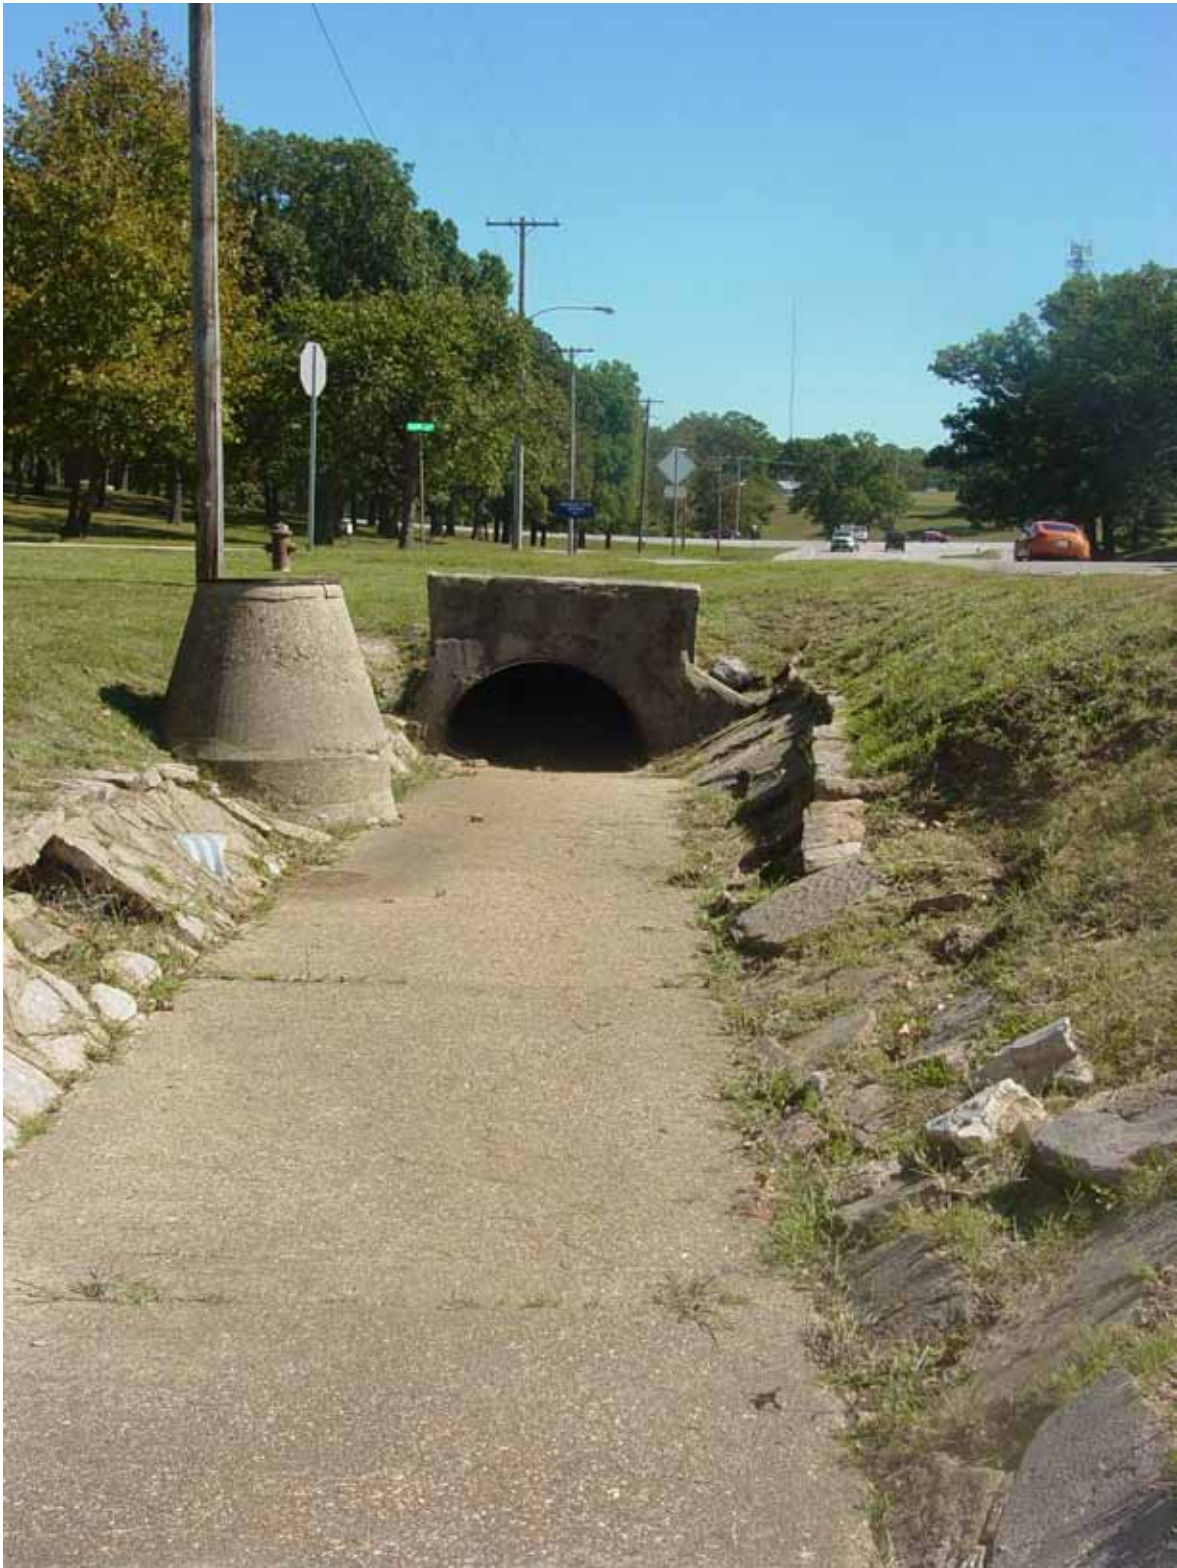
Figure 26. Overall elevation, west end of culvert.

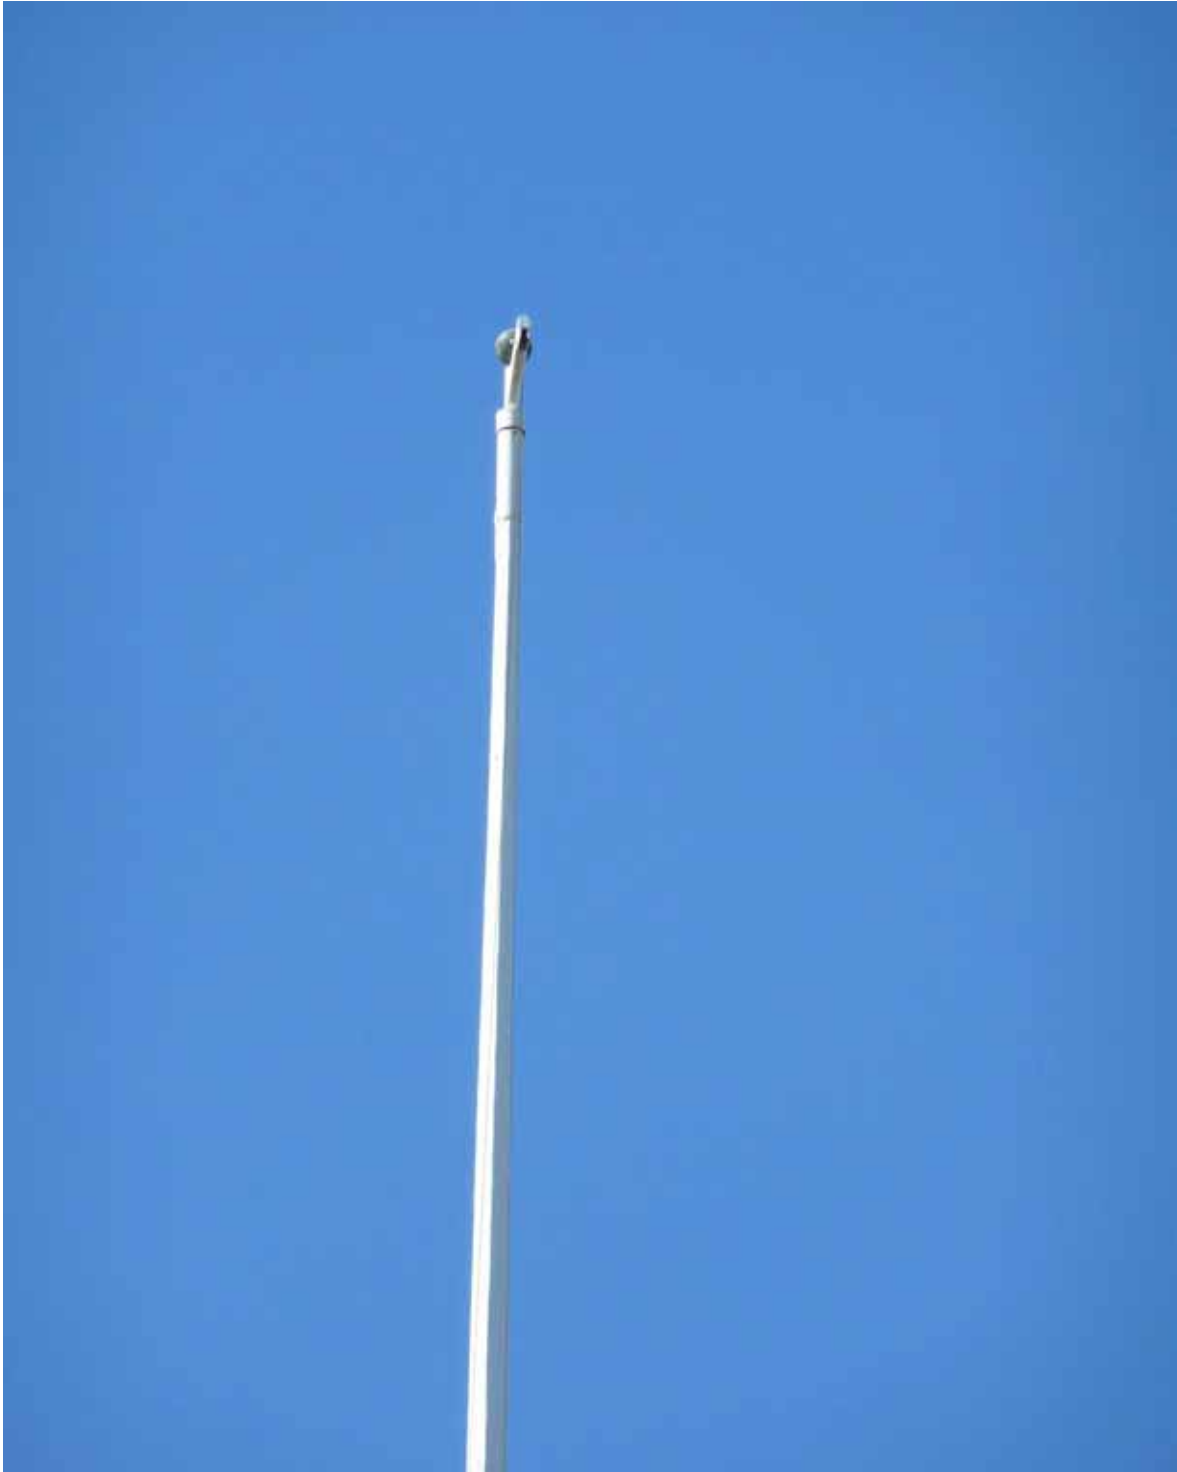
The flagpole is painted white and the paint remains in relatively good condition. A hand crank on the east side of the pole has also been painted white, but rust is beginning to show, especially at the edges.

Figure 35. Top of flagpole.

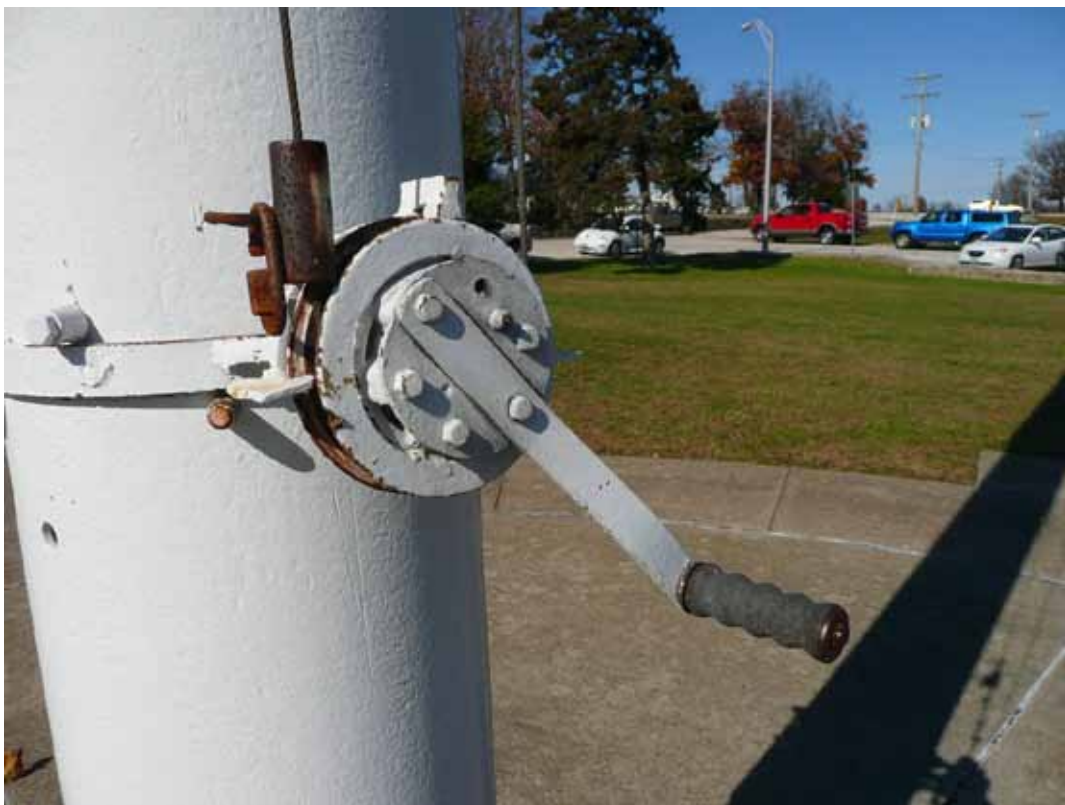
The steel tube overall seems to be in good condition. The hand crank is somewhat worn and rusted, but seems to be in good condition as well.

Figure 37. Detail of flagpole hand crank.

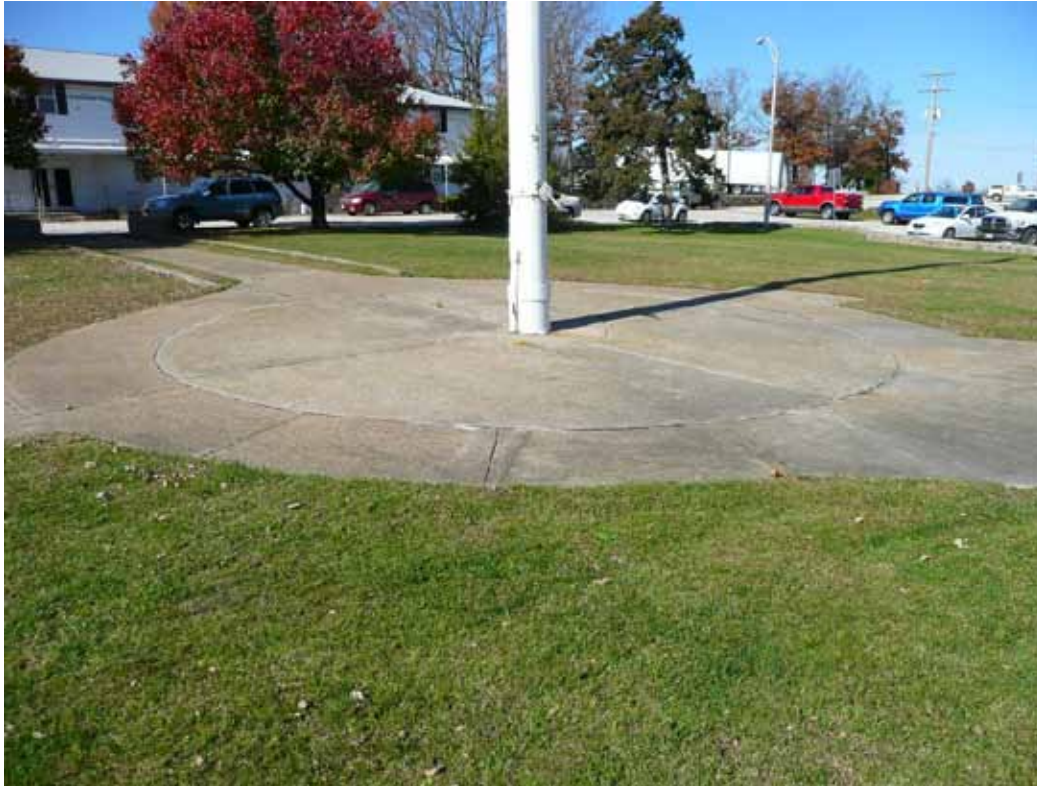
Figure 41. Close-up of flagpole base.
